INTELLIGENT
DESIGN
ENGINEERING

At your request, a visit was made to the referenced address on October 20, 2016 to determine the structural requirements for removing two walls. *All directions are given with respect to someone facing the front of the house from the street.*

WALL REMOVAL PLAN

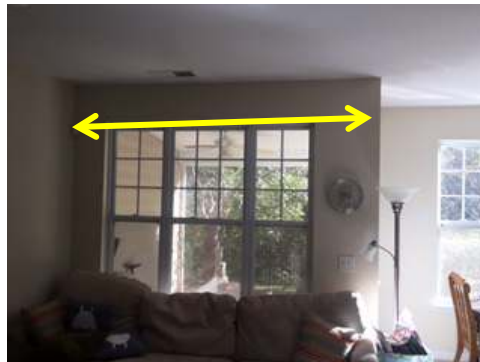
The rear wall of the living room and the wall running from front to back at the left of the dining room are to be removed. The left dining room wall is non-load bearing and can be removed or altered as desired. The rear wall of the living room, however, is load bearing. See the photo below.

The removal of this wall requires the installation of a new dropped (3)-1 $\frac{3}{4}$ "x9 $\frac{1}{4}$ " LVL spanning approximately 9'-0". The left side of the beam must be supported with (3)-2x4 studs set in the left living room wall and should bear over the existing continuous concrete footing between units. The right bearing end of the beam, which is also the left bearing end of the existing beam over the dining room should be supported with a new 5 $\frac{1}{4}$ "x5 $\frac{1}{4}$ " PSL column. The column should be placed directly under the existing beam and the new beam should be supported on the side of the column with a new Simpson HUCQ612-SDS concealed flange hanger. The new column should be attached at the bottom with a Simpson ABW66z post base. The contractor must verify at least 6 square feet of continuous concrete footing under the new post or add a new 30"x30"x10" concrete spot footing directly below the post bearing over 2,000psf bearing soil. Refer to the wall removal plan attached to this report for clarification and relevant information.
