INTELLIGENT  
DESIGN  
ENGINEERING

At your request a visit was made to the referenced address on August 23, 2016 to inspect some crawlspace repairs as well as recent cracks in the brick veneer at the front of the house.

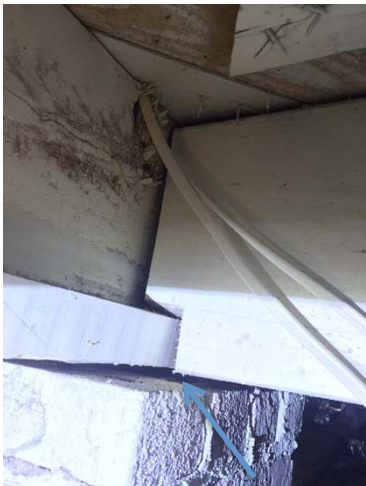
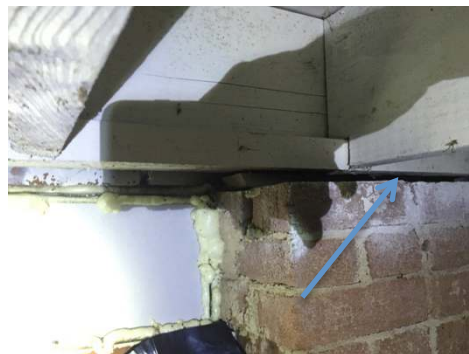
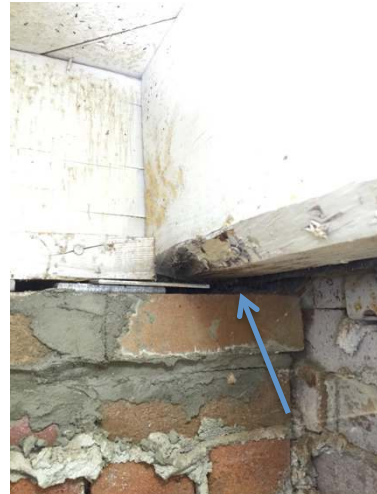
It is my understanding that you purchased the house about a year ago. At the time of purchase, a home inspector had noted several items in the crawlspace in need of repair that a contractor had subsequently repaired. I reviewed those items and found that all of them were corrected as noted with the exception of a few piers that still needed it to be shimmed in my opinion (see photo below for an examples). Two piers are located at the rear wall near the left side and one is located at the front left corner.

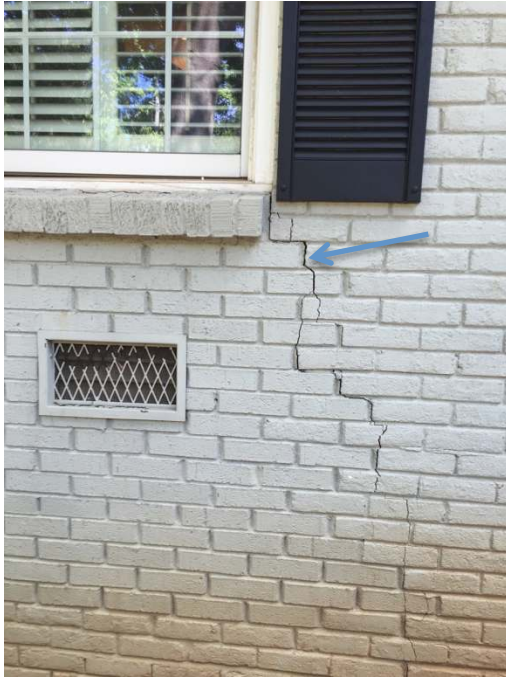
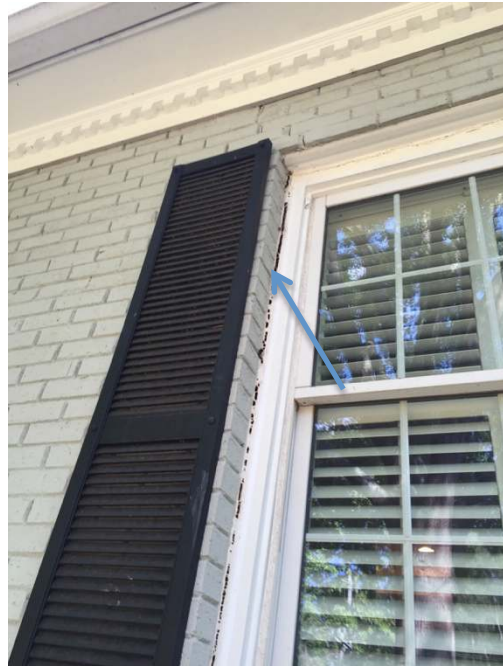
The crack in the brick veneer at the front left of the house under the window is slightly more concerning and structurally significant (see the photos below of the referenced crack). This crack was noted by the home inspector as being an eighth of an inch wide and it was structurally insignificant in his opinion but since you had lived there it has worsened. Using a laser level, I measured the foundation which slopes towards the left rear corner approximately  $\frac{3}{4}$ " and towards the left front corner approximately  $1\frac{1}{2}$ ". Differential settlement can be

expected on homes but normally anything over about a 1/2" is concerning. There is evidence that these cracks had developed prior to you moving in and had been patched, which indicates that this has been an on-going problem. The photos below are of the crack at the front left bedroom window where the more significant settlement is present and actively moving.

Given the history of movement, the amount of movement and the fact that movement is still active, further actions are needed. The left side of the house is settling which may require deep foundation solutions such as helical piers or grouted micropiles installed to stabilize the foundation. However, given the extent of the movement I would recommend that a soils engineer evaluate the soils characteristics prior to performing any repairs. Have the soils engineer check the soil stiffness and plasticity at all four corners of the house and towards the middle of the rear and front wall for a total of six locations. An evaluation of the soils plasticity will help determine if the soil is expansive in nature and the movements may be due to fluctuations in moisture content of the soil. Knowing this will help determine the most appropriate repair considerations. Please have the soils engineer forward us a copy of the report in order to determine whether or not a repair is warranted and what the repair should consist of.

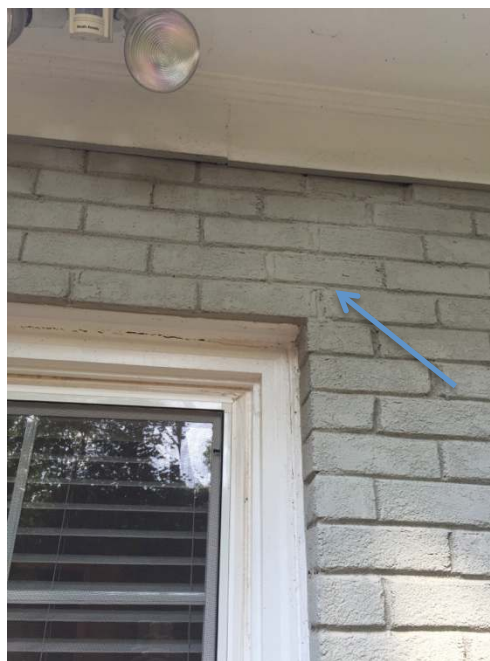
The photo below shows the window at the left rear bedroom at the rear wall where patched mortar was observed.
