At your request, a visit was made to the referenced address on May 13, 2026, to inspect specific structural concerns noted in a recent home inspection report for the house that you are under contract to purchase. Public property records indicate this house was built in 1973. The following items were noted at the time of the inspection. All directions are in reference to a person facing the front of the house from the street.

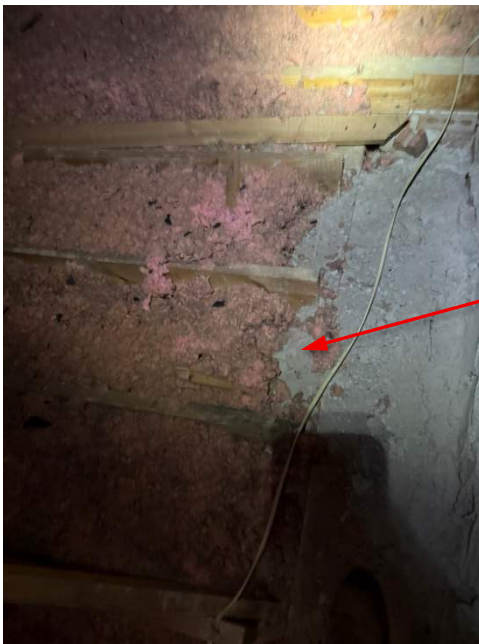
1. The home inspection report indicated a missing roof brace forward of the main center chimney. The roof framing in this area consists of 2x6 rafters spaced at 16 inches on center spanning a horizontal projected distance of approximately 13 feet 6 inches. This span is acceptable under current building code requirements for roof rafters without the need for intermediate bracing. Accordingly, no additional intermediate roof bracing is considered necessary. While inspecting this area, however, it was noted that the ceiling joists forward of the chimney do not have adequate blocking to brace them against rotation. A 2x6 band should be installed to tie the joists together over the top of the wall plate, or alternatively, solid blocking should be installed between the joists at this location. See the photo below.

Add blocking between  
joists

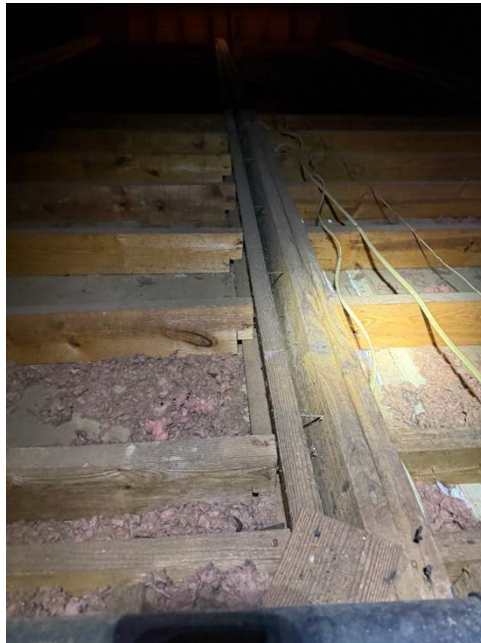
2. The ceiling framing over the garage consists of 2x6 ceiling joists framing into a center triple 2x8 girder. The girder plies have separated substantially, compromising the connection between the ceiling joists and the girder. As a result, the garage ceiling has cracked significantly. Measurements taken within the garage indicate that the front wall

is leaning outward approximately 1.25" to 1.5 inches, while the rear wall containing the garage doors remains plumb. Cracking observed in the front foundation wall suggests that the front footing has rotated outward rather than settled vertically. This condition has caused the top of the wall to pull outward, which in turn has contributed to the separation of the center garage girder and has been further exacerbated by the tension forces imposed by the roof framing. The existing connection at the center girder did not provide sufficient tensile capacity to restrain the top of the front wall against this movement.

This type of footing rotation is commonly associated with poor drainage conditions. Much of the front foundation wall was concealed by vegetation at the time of the inspection and should be cleared to expose the base of the wall. A qualified moisture mitigation specialist should evaluate drainage along the front side of the house and implement corrective measures to ensure that water is directed rapidly away from the foundation. Although the cracks in the front foundation wall are likely attributable to this footing movement, there is no indication that the underlying soils are soft or have inadequate bearing capacity. Accordingly, underpinning repairs are not recommended at this time. Improved drainage should help prevent further movement.

*Girder ply separation*

The ceiling framing over the garage is in a condition that presents a risk of collapse if not repaired. The existing girder should be removed and replaced with a wider multiply girder in accordance with the attached repair detail.

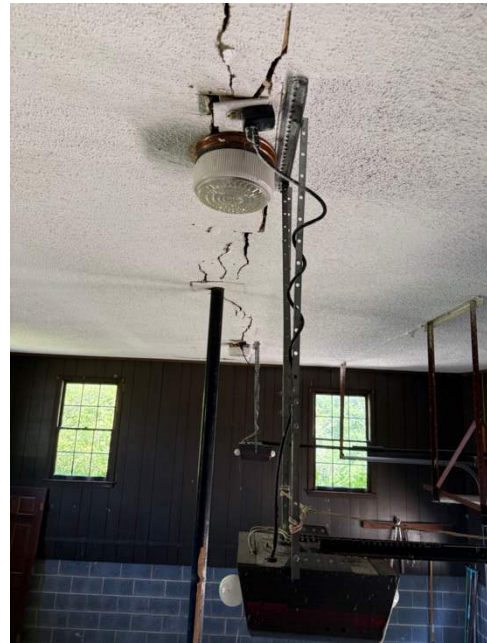
*Resulting crack in ceiling*

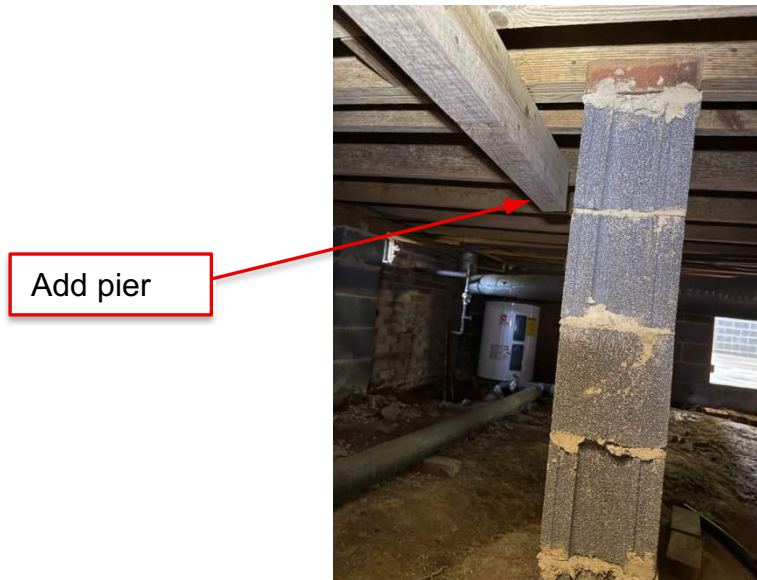
3. In the crawlspace, the intermediate dropped girder beneath the center of the front living room is not supported at either end. A masonry pier should be added at each end adjacent to the existing piers that were likely intended to support the girder. A similar condition exists at the intermediate dropped girder located to the right of the foyer. Each

end of this girder should also be supported with a masonry pier (4 piers total). Each pier should bear on 22"x22"x7" concrete footings. See the photo below.

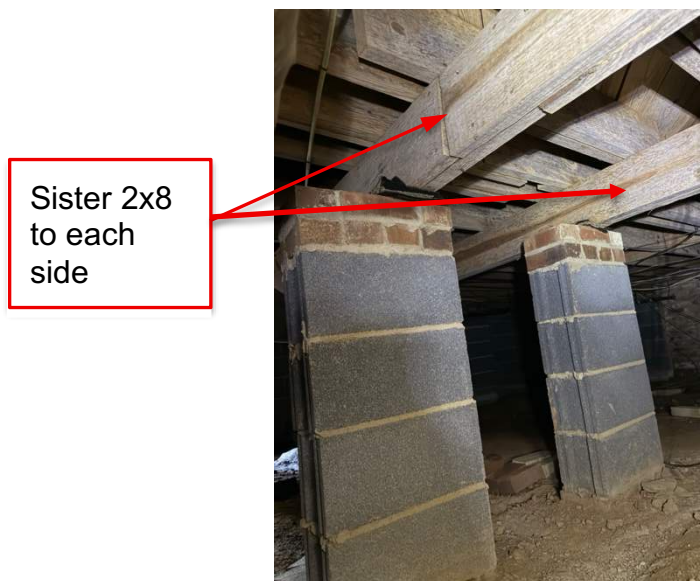
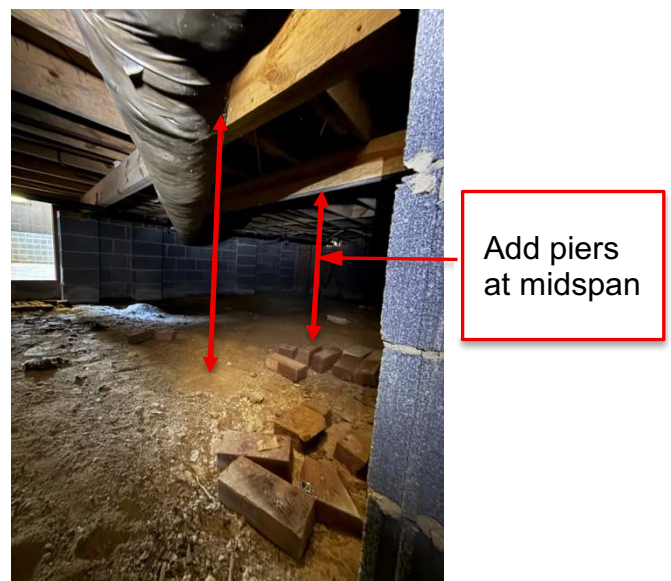
4. The two center dropped girders to the left of the chimney are spliced at locations beyond the supporting pier, creating a structural weakness. In addition, the spans to the left of the piers are approximately 11 feet, which is excessive for the tributary loads imposed on these members. To correct these deficiencies, sister a 2x8 member to each side of both spliced girders to the left of the chimney. In addition, construct a masonry pier at the midpoint of the 11-foot span of each girder, bearing on a 22-inch by 22-inch by 7-inch concrete footing. These new piers will reduce the effective span to approximately 5 feet 6 inches, which is more appropriate for the applied loads.

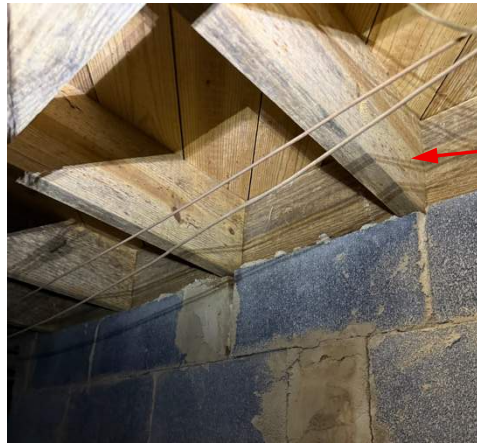
5. The floor joists framing into the rear of the chimney do not have adequate bearing and are not properly connected to the band joist. Install two Simpson Strong-Tie A35 clips at each joist, one on each side, using No. 9 x 2 1/2-inch Simpson Strong-Tie SD Connector Screws. A similar condition exists at the joists located at the front of the

fireplace. Similar brackets may be used at these locations, or a Simpson Strong-Tie LUS28Z joist hanger may be installed instead.

Add  
brackets

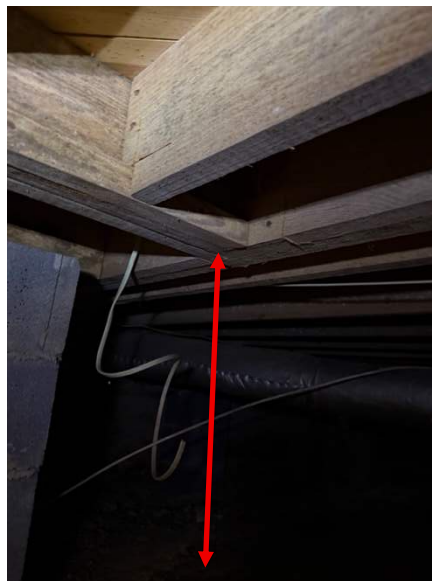
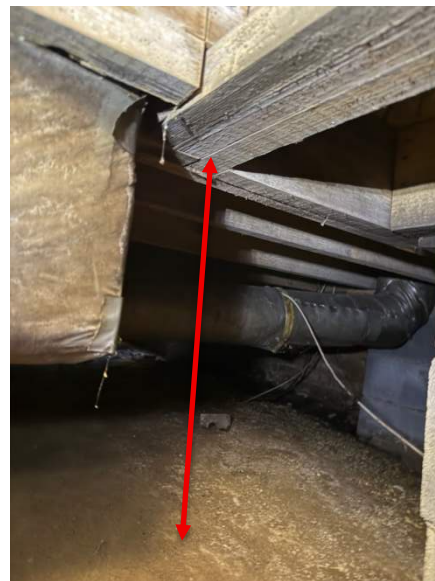
6. The two middle girders to the right of the fireplace are spliced at locations that do not bear over masonry piers. Similar to item #4, sister a continuous 2x8 member from pier to pier along each side of both girders to restore structural continuity.
7. At the front entry, the header spanning left to right is inadequately supported at both ends. Construct a masonry pier beneath each end of this header to provide proper support.
