At your request a visit was made to the referenced address on May 4th, 2026 to inspect the structure, with particular attention to items recently noted in a prior home inspection report. Public property records indicate this house was built in 1977. With homes of this age, one can expect there to be some framing conditions that do not meet today's Code requirements. With that in mind, the repairs recommended in this report are intended to prevent further deterioration and address damaged areas or areas of insufficient support that may influence the safety and performance of the structure under normal use. The following items were noted at the time of the inspection with any photos relevant to that item immediately following:

Garage Ceiling Repair Plan

**Structural  
Drawings**

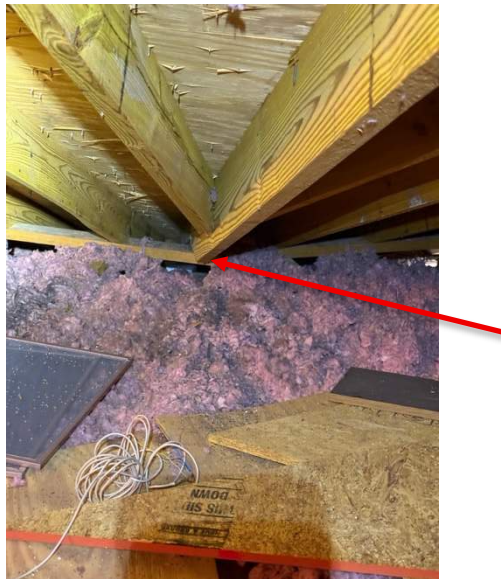
1. In the front attic, the valley rafter at the center bears on a single 2 x 4 plate. Although this condition raised concern in the home inspection report, the member is relatively lightly loaded and the existing bearing condition is sufficient to support the imposed loads.

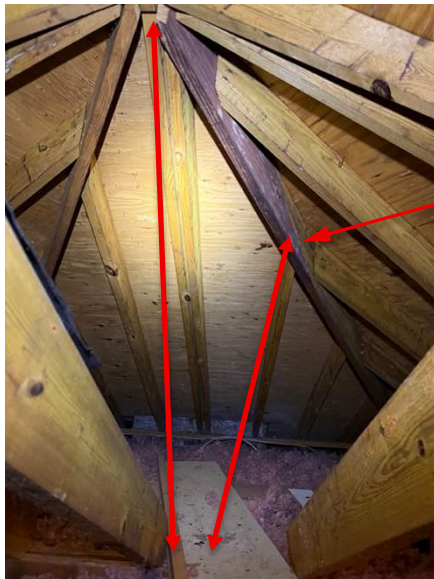
2. At the rear center attic area forward of the chimney, the overbuild roof framing includes a hip rafter with a birdsmouth splice that lacks adequate bracing. This condition should be corrected by installing a roof brace at this splice. Additionally, the peaks of the hip rafters where they meet the ridge board should be braced. These braces should bear over the beam spanning across the living room to ensure proper load transfer. See the photo on the following page.

Add double 2x4  
braces

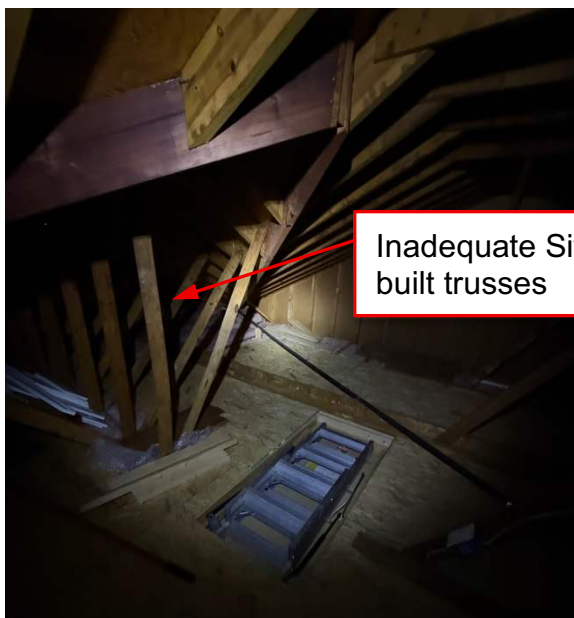
3. The ceiling over the garage exhibits a significant sag, which is attributable to overspanned ceiling joists running laterally across the garage. The original construction attempted to create a site-built truss system; however, the geometry of the roof prevents this system from functioning as intended. As a result, the roof and ceiling framing over the garage has sagged, is deficient, and requires reinforcement. Installation of properly designed beams within the garage ceiling is necessary to adequately support the roof structure, consistent with the referenced repair approach. See the attached repair plan for further information.

Inadequate Site-  
built trusses

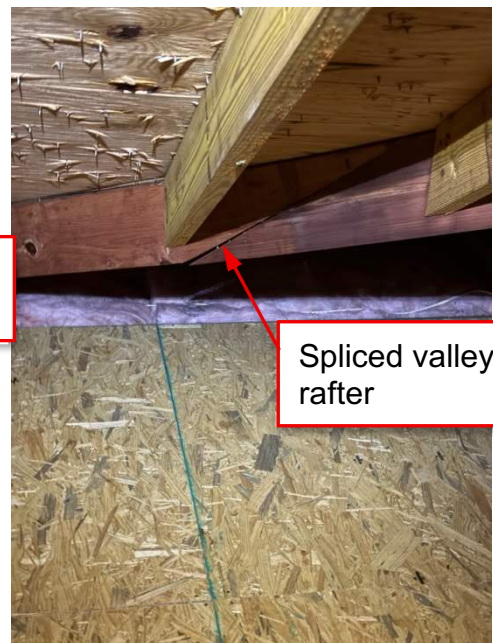
Spliced valley  
rafter

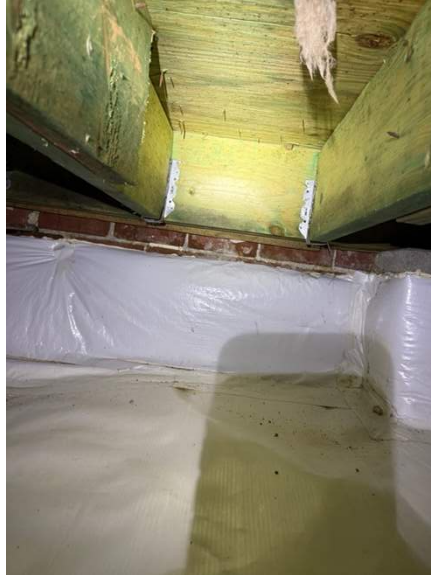
4. Within the crawlspace at the front of the home, particularly beneath the dining room and living room areas, prior decay necessitated replacement of the front band board. During this process, the original joists were cut short to facilitate removal. These joists were

subsequently reinforced with 2 x 10 scab members approximately 6 feet in length and connected to the new band using metal hangers. While this approach can be effective if properly executed, improved performance would be achieved by replacing the joists entirely with full-length members. As installed, the scab members require additional fastening consisting of a minimum of three rows of 0.131-inch diameter by 3-inch-long nails spaced at 8 inches on center to ensure composite action. The joist hangers also require correction, including proper seating beneath the joists and reattachment using appropriate fasteners such as No. 9 by 2 1/2-inch Simpson SD screws.

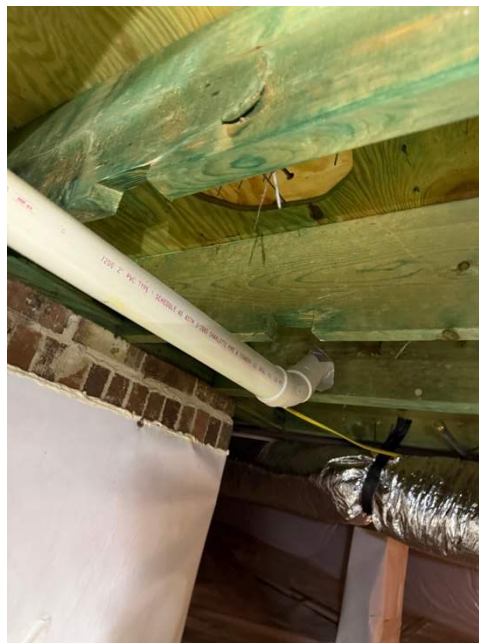
5. A couple of joists beneath the kitchen area have been notched beyond prescriptive code limits. However, based on their location and extent, these notches are not considered structurally significant and do not require reinforcement.

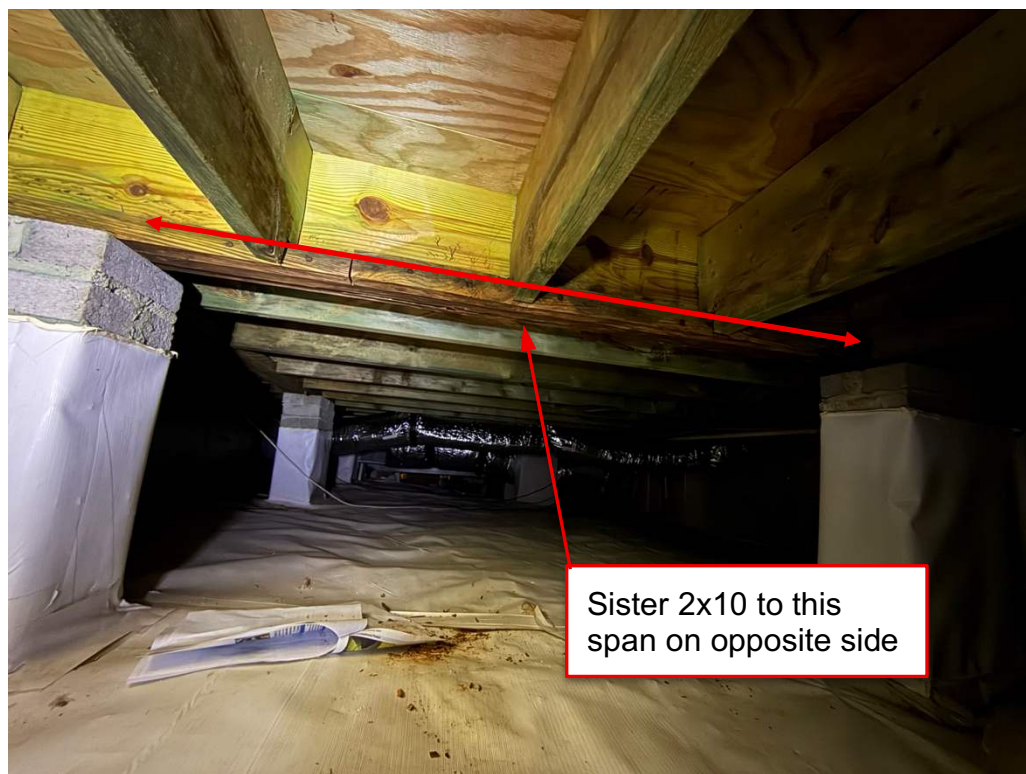
6. At the right side of the crawlspace beneath the hallway, fungal decay has compromised portions of the supporting girder and adjacent joists, including the 2 x 2 ledger supporting the joists. The lower portion of these members has deteriorated. Each joist framing into this girder should be reinforced using Simpson A35 brackets (or equivalent) to secure the joists to the upper, more structurally sound portion of the girder.
7. A similar condition exists along the girder supporting the left side primary bedroom wall. The same reinforcement method should be applied along this span to improve joist-to-girder connections.
8. At this same girder, additional reinforcement is recommended by sistering a 2 x 10 member along the left side over the approximately 6-foot span located just to the rear of the hallway girder intersection. See the photo below.

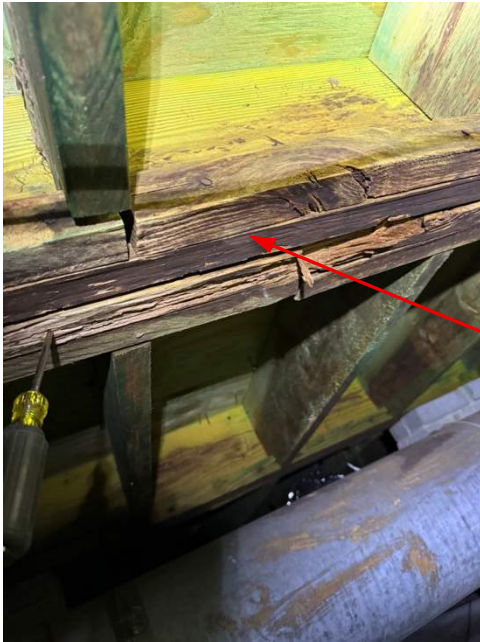
9. At the girder supporting the front hallway wall on the right side of the home, a section near midspan exhibits structurally significant fungal decay. This condition should be addressed either by replacing the affected girder section between piers with a comparable treated double 2 x 10 member or by installing an intermediate masonry pier to reduce the effective span. If a new pier is installed, the deteriorated lower 2 inch portion of the girder should be removed to expose sound wood, and the new support should consist of 8 x 16 CMU bearing on a 22-inch by 22-inch by 7-inch concrete footing. Joists should then be securely connected using Simpson A35 brackets as previously described. See the photo on the following page.

Damaged girder

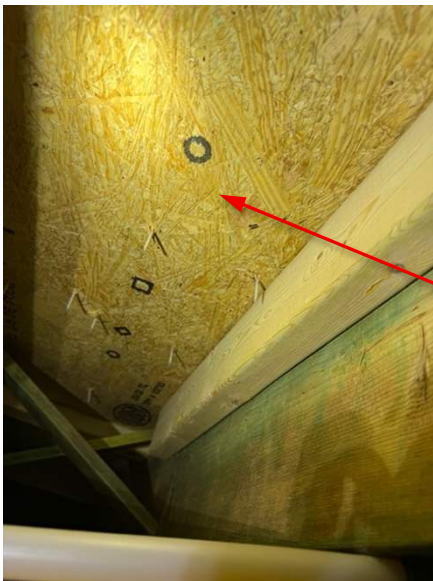
10. Beneath the bathroom, the OSB subflooring has been installed with improper orientation. To address this, install 2 x 4 ladder blocking at 24 inches on center perpendicular to the joists. Blocking should be secured with toenails or Simpson LU24 hangers to provide adequate support to the subfloor panels.

Add blocking

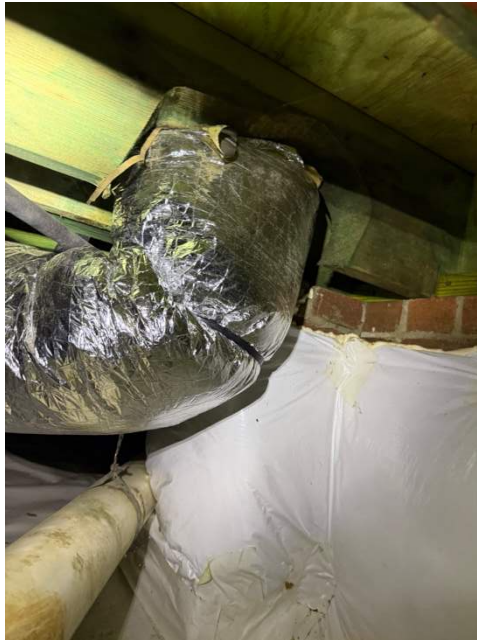
11. At the front foyer, a floor joist has been excessively notched to accommodate a supply duct. Reinforcement is recommended by sistering a 2 x 6 member along the upper portion of the joist to restore structural capacity. See the photo on the next page.
