At your request, a visit was made to the referenced address on May 12, 2026, to evaluate the unevenness of the rear addition, particularly in the area of the primary bathroom extension. Public property records indicate the original house was built in 1940. *All directions are in reference to a person facing the front of the house from the street.*

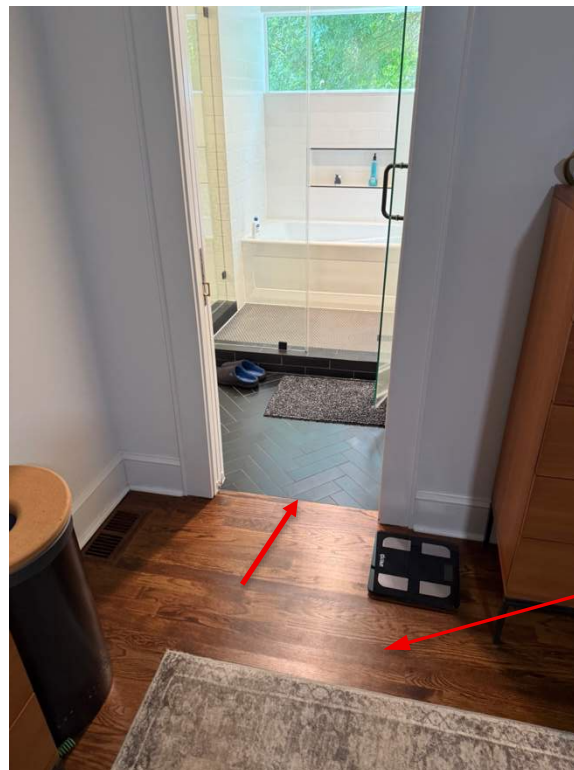
You indicated that the addition to the rear of the house was constructed a couple of years ago. Since that time, you have noticed a slope in the floor leading from the rear of the primary bedroom into the primary bathroom. Measurements obtained using a self-leveling laser indicated that the floor drops approximately 3/4 inch at the transition between the original house foundation and the rear addition. This drop occurs almost immediately upon entering the bathroom and then remains at a relatively consistent elevation to the rear wall of the bathroom. See the photo below.

Slope starts here at transition

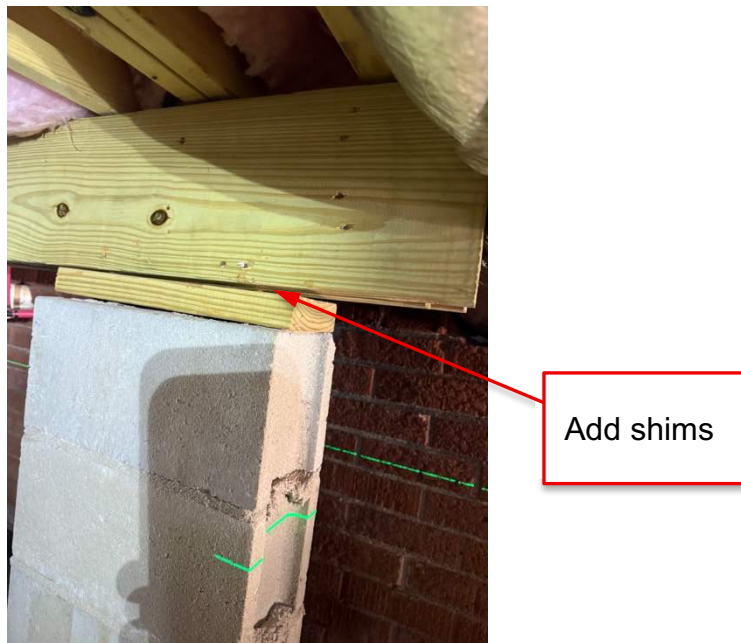
Any minor movement that may have occurred since construction appears to be limited to normal wood shrinkage of the girder supporting the bathroom floor joists adjacent to the original foundation. This shrinkage may account for a very small amount of separation observed between the bathroom cabinet and the adjacent wall. A slight looseness was also noted at the contact point between the girder and the left pier, likely due to this shrinkage. This pier can be shimmed to ensure firm bearing against the girder it is intended to support.
